Chatsworth Community Centre

Structural Inspection Report - 2017 Township of Chatsworth

GMBP File: C-7711

April, 2017

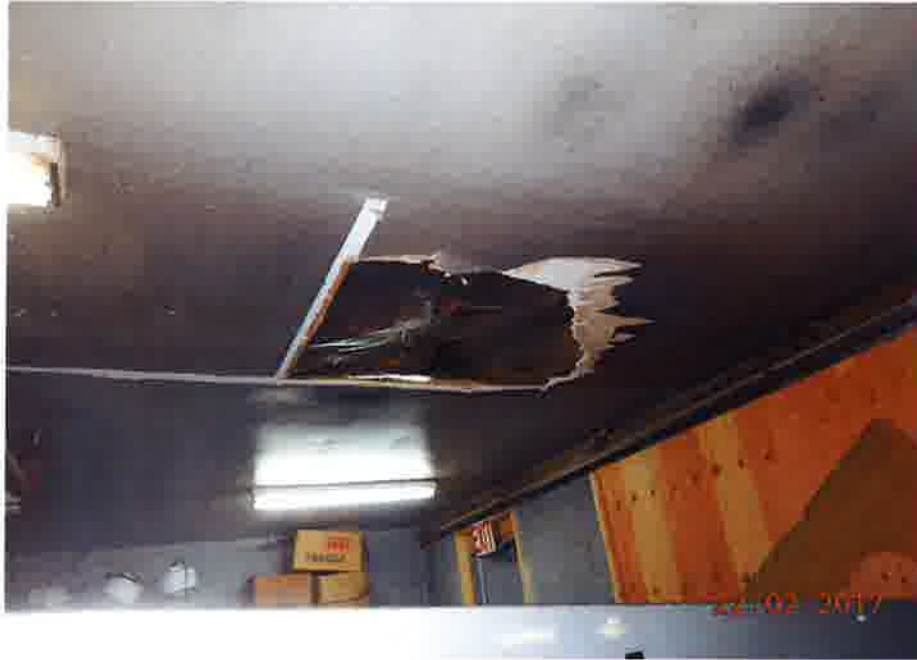
3. Due to ingress of water the Zamboni roof is now to the point where it requires total replacement. On the exterior the fascia board and soffit have severe rot present. Mold was noted throughout the ceiling on the interior of the Zamboni room so care should be taken when performing this work.

Photo 5: View of moisture and mold located in Zamboni room ceiling.

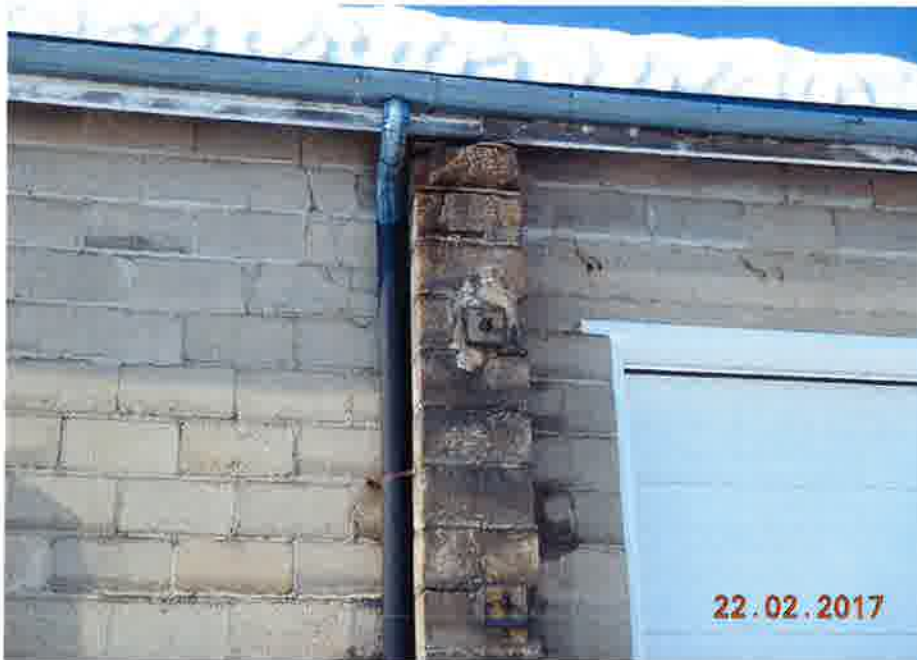
5. The concrete block pilasters on the north side of the structure appear to be bowed out. The pilasters on the south have continued to deteriorate due to moisture from the leaking downspouts. The overall structural integrity of these members is questionable and reinforcement should be installed.

Photo 6: View of typical pilaster deterioration.

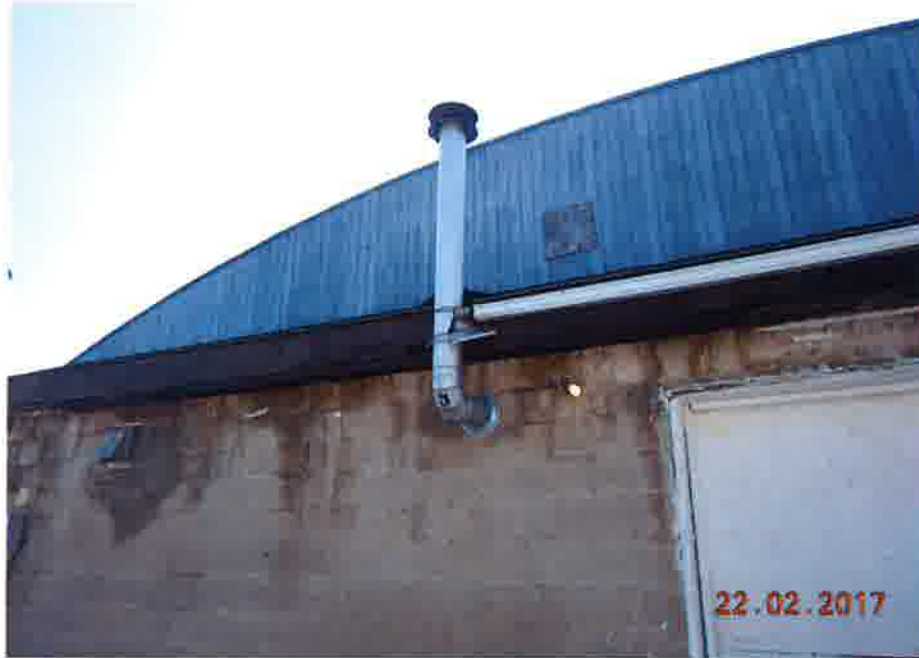
Photo 7: View of missing eavestrough and rotting fascia board.

6. Continue to treat the base of each timber column with wood preservative on an annual basis.
7. Install eaves troughs and downspouts on the north side of the change room addition.

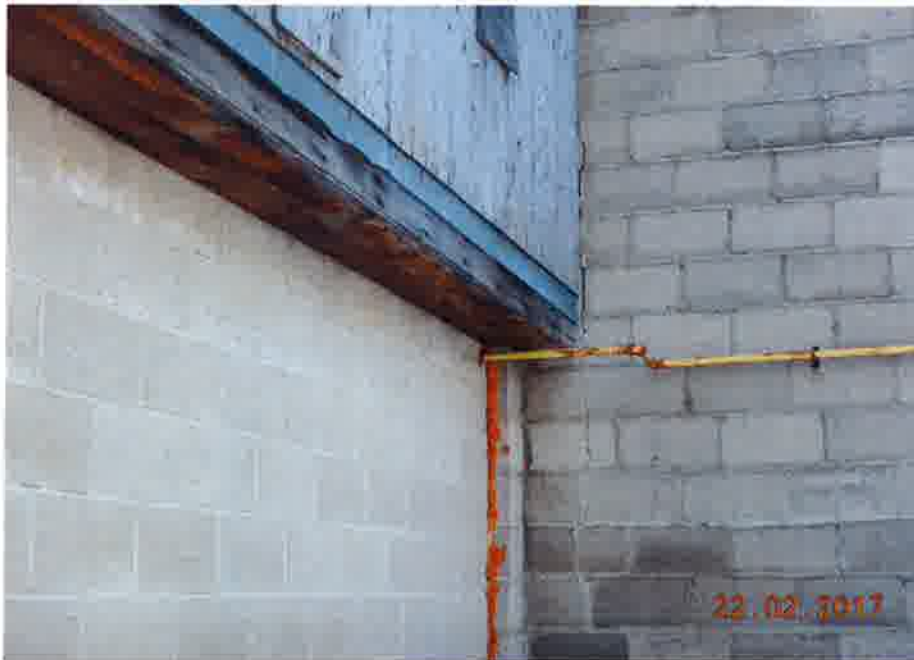
Photo 8: View of rotting soffit located outside the Zamboni room.

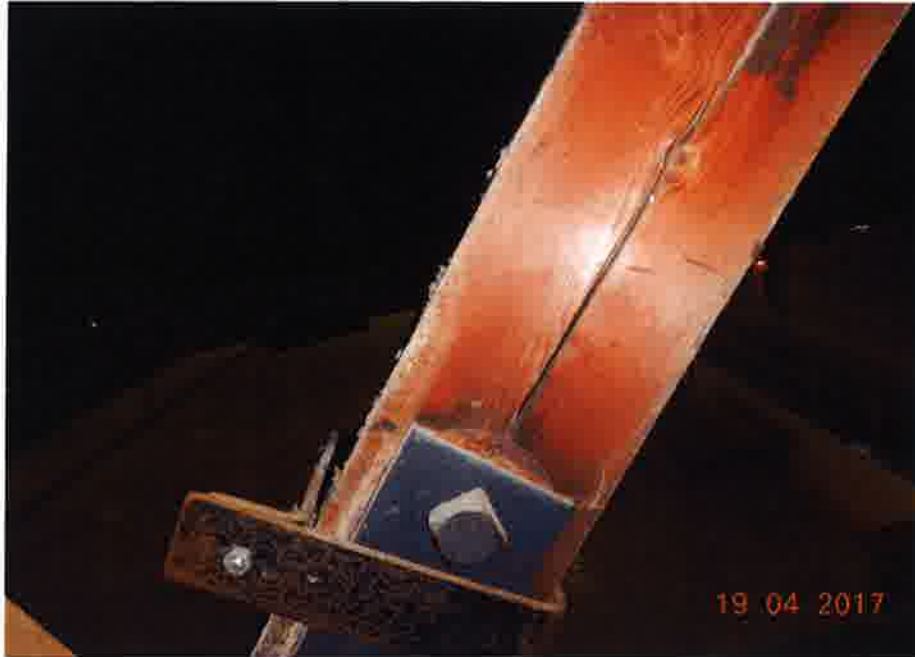
2. Several splits were noted throughout the roof trusses, particularly in web members. A previous attempt of reinforcement included installing steel straps around the ends of the members. The web members are no longer in contact with the top and bottom chords, presumably due to shrinkage, this is causing all forces to be transferred through the fasteners which is likely causing the observed cracking. The members have continued to split and replacement may be warranted.

Photo 9: View of typical split in truss web member.

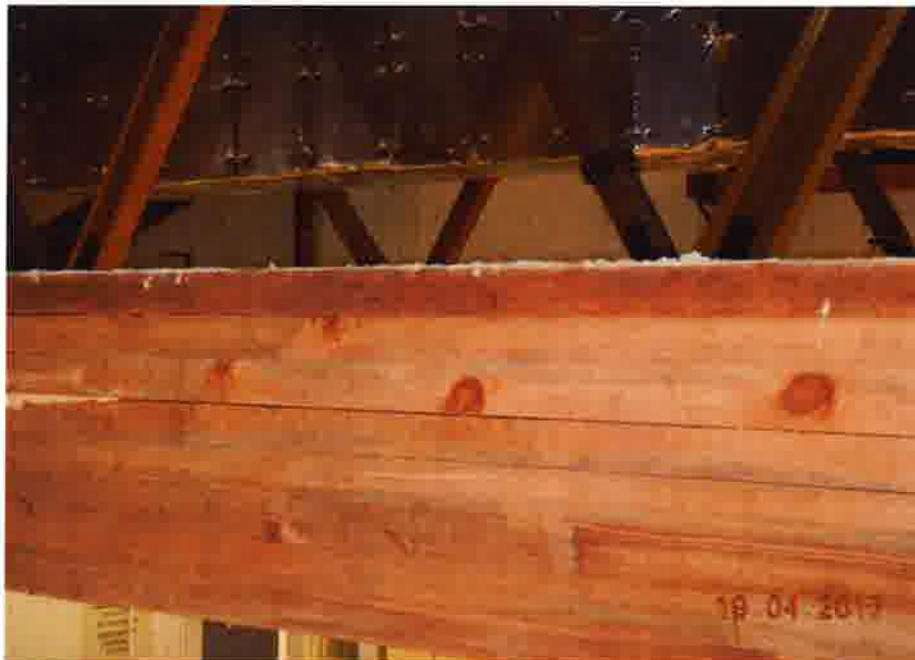
1. The top and bottom chords of the roof trusses above the arena are laminated 2x4 members. Several of these members are delaminating from one another and now several cracks are present. Reinforcement of these members should be completed to restore the integrity of the trusses.

Photo 10: View of delaminating of bottom chord.

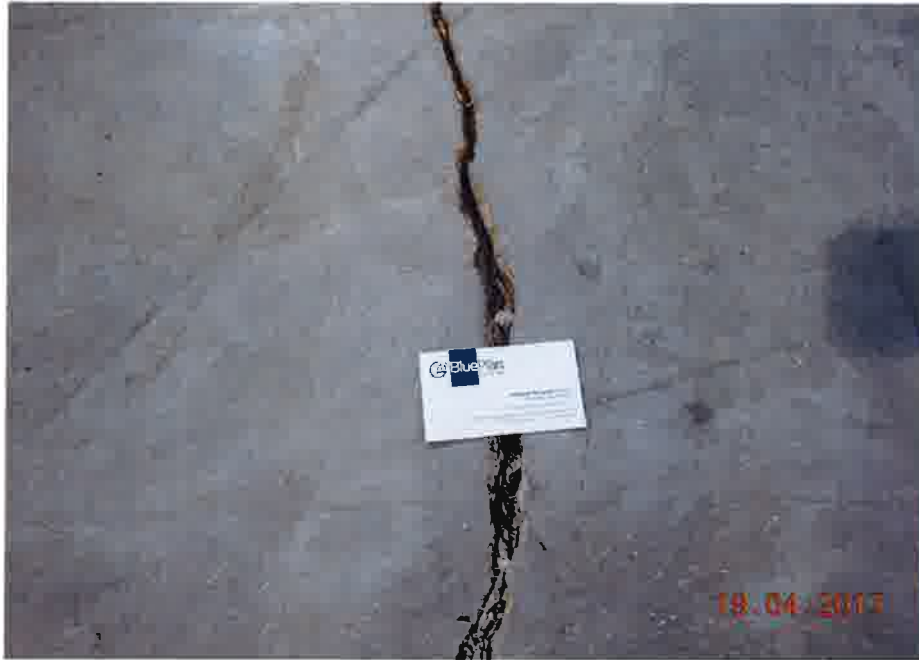
Photo 11: View of wide crack in floor slab.

12. Relocate or provide a weather tight seal around the electrical panel on the exterior south wall of the structure at the west end.
13. Epoxy inject the wide crack in the concrete slab on grade which runs east to west and the north side of the arena. This will prevent moisture from getting into the crack and causing further damage to the slab.

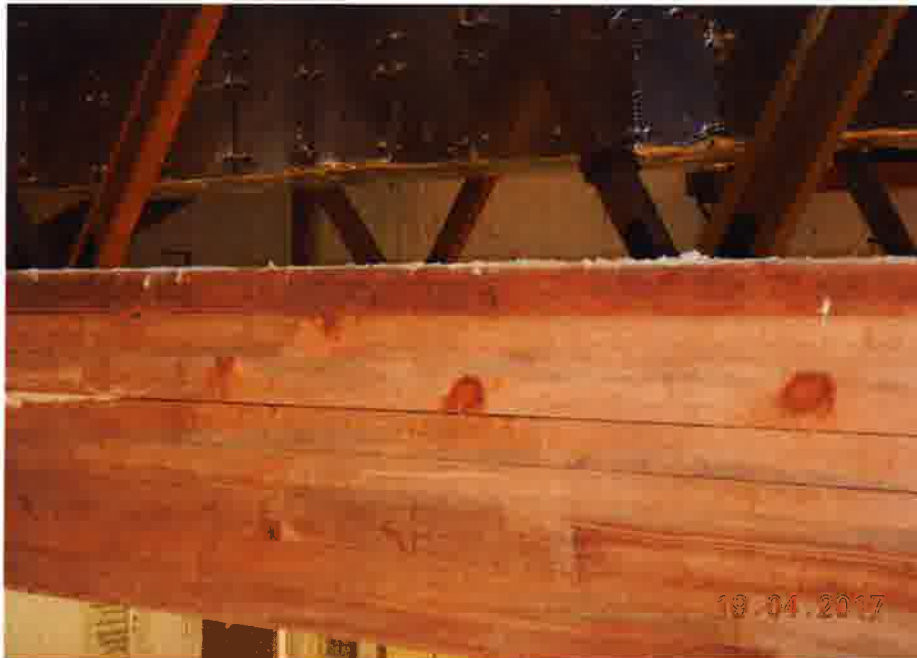
Photo 12: View of delaminating of bottom chord.

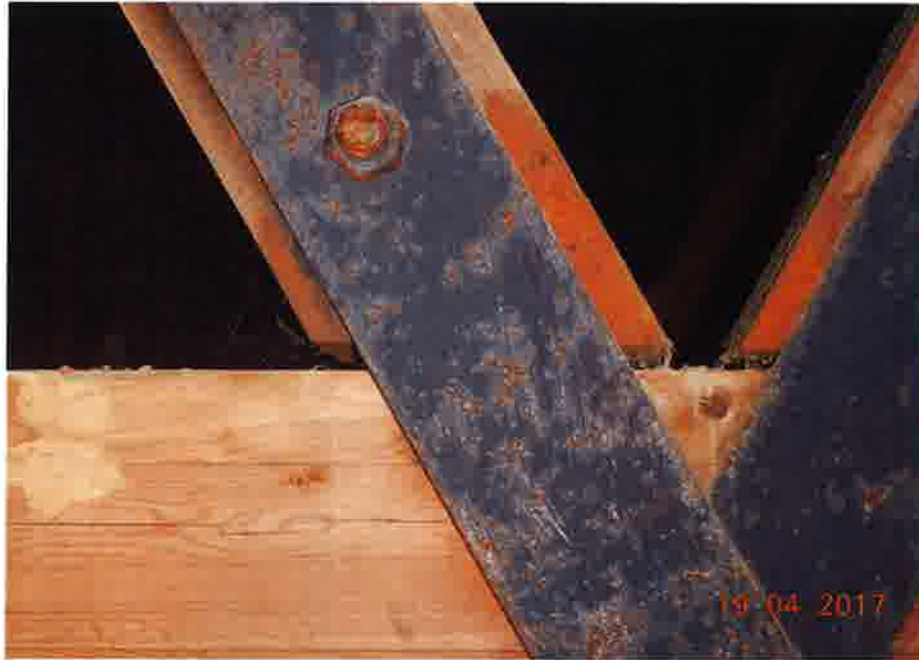
Photo 13: View of gap between webs and bottom chord of trusses.

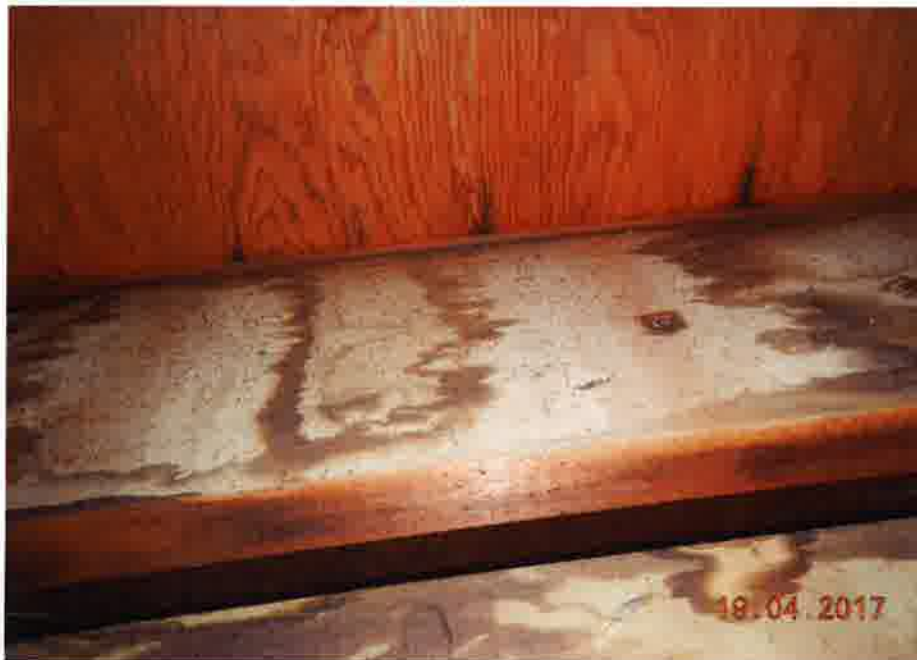
4. Historical water damage and mold is present throughout the roof system, particularly the 2x10 purlins which span between the trusses. Environmental testing should be conducted immediately to determine if the mold observed is a health concern. Significant investment in upgrading the HVAC system is required to eliminate the mold from returning.

Photo 14: View of typical moisture damage on roof purlins.

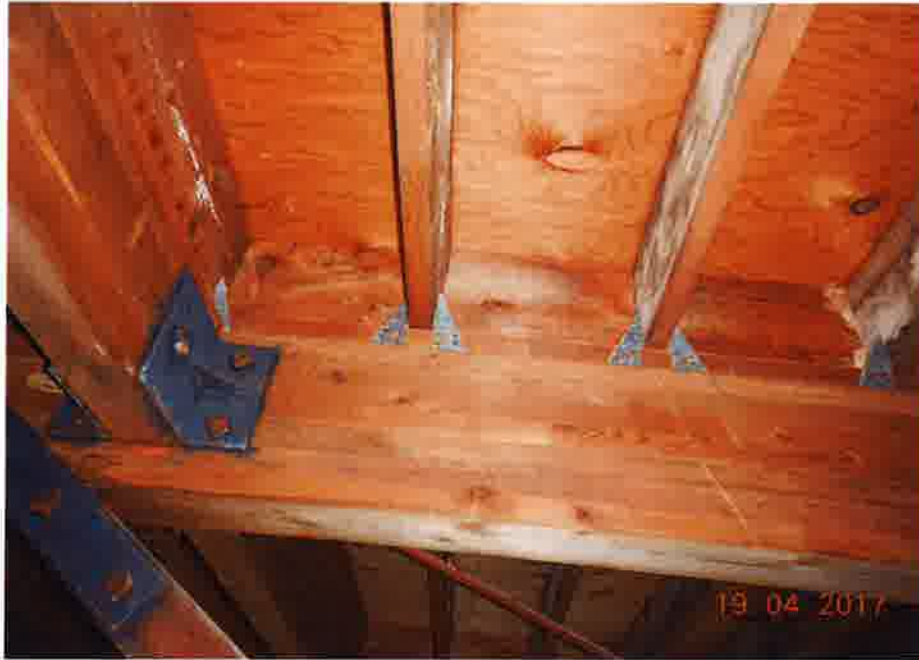
Photo 15: View of typical mold on purlins.

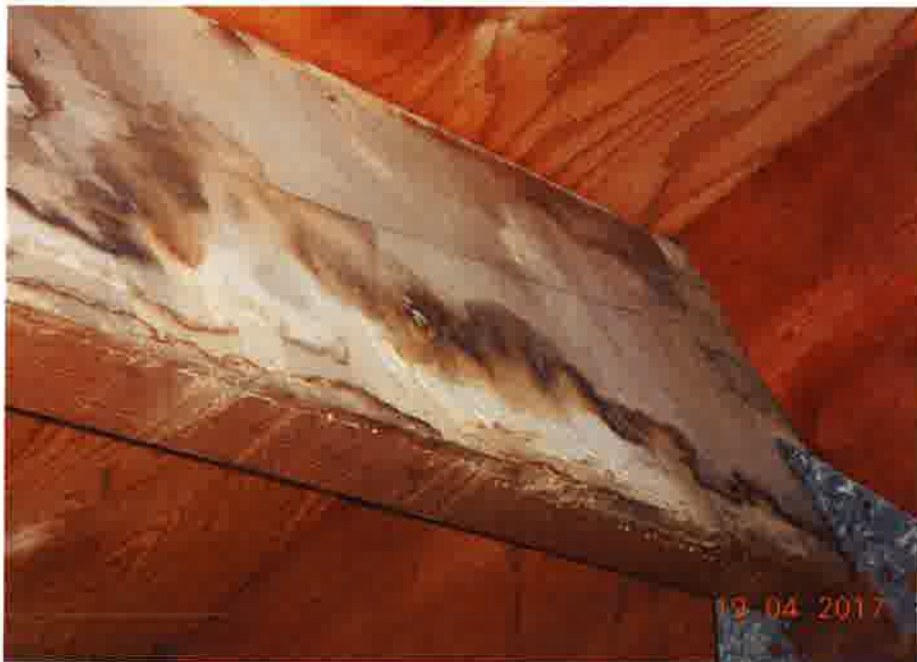
Photo 16: View of typical moisture damage and mold on roof purlins.
