June 9, 2017
Our File: C-7711-2

Re: Pre-Abatement Mold Assessment
Chatsworth Arena – 5 Toronto Street
Township of Chatsworth

Pre-Abatement Mold Assessment - Chatsworth Arena (5 Toronto Street, Chatsworth)

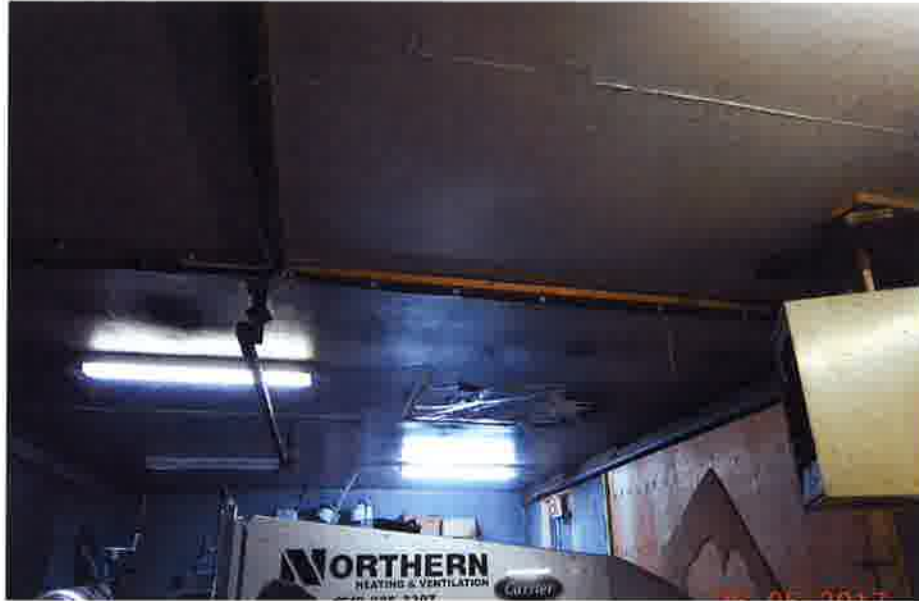
Based on discussions with the client, it appears that there has been historical water damage and subsequent mold growth within the Zamboni room and main arena area over a period of several years. Reportedly, severe rot of the fascia and soffit of the roofline of the Zamboni room has caused subsequent water damage (partial ceiling collapse was noted during the site investigation). Evidence of water damage was observed (including staining and visual mold growth) on portions of the ceiling within the Zamboni room at the time of the site visit. Additionally, mold growth was noted on the trusses within the main arena area, where water damage and staining was observed.

Photo 1 - Water damage and mold growth observed within Zamboni Room.

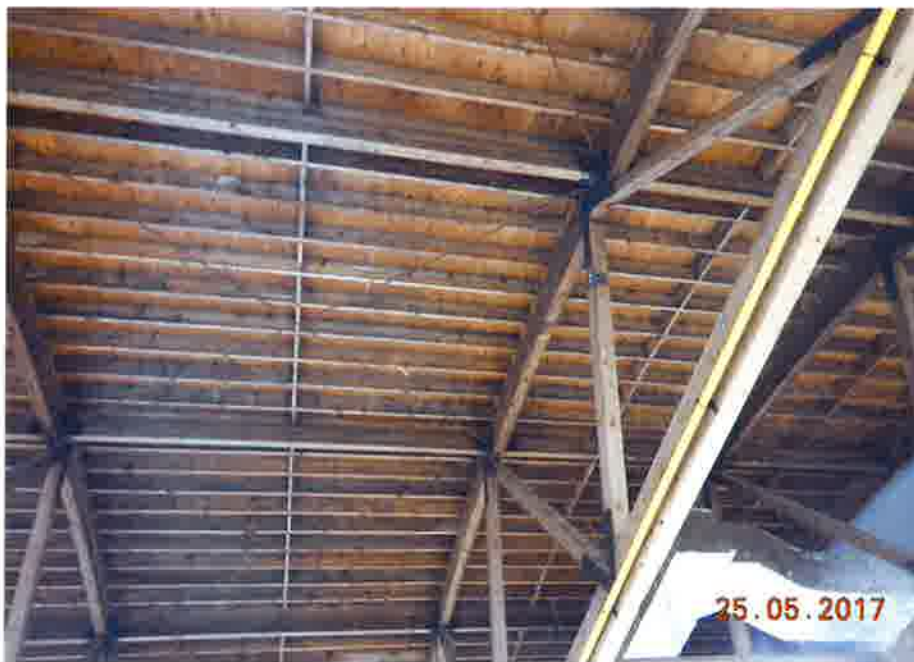
It is of note that the sample collected from the main arena area (i.e., SA-3) was collected from the lower trusses of the arena roof due to the accessibility at the time of the sampling program. The majority of the mold and water damage was noted on the top wooden trusses, approximately 15 to 20' above the lower trusses.

Photo 2 - Wood trusses within main arena area, where evidence of water damage and mold growth was observed.

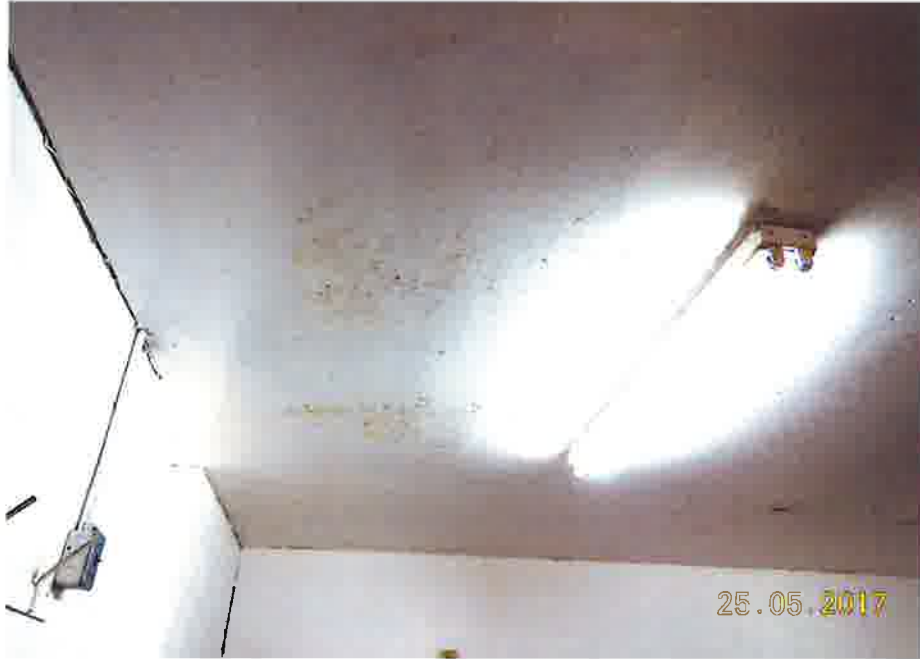
Photo 3 - Mold growth observed on ceiling of Dressing Room # 4.

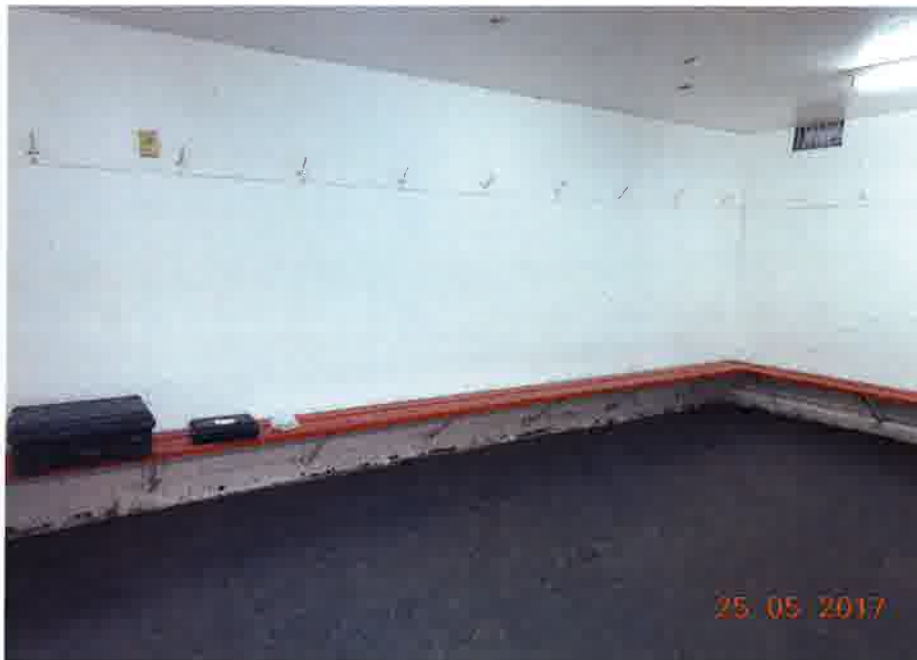
Photo 4 - Additional view of Dressing Room #4 where mold growth was observed.
